## Division of Emergency and Remedial Response Site Cleanup Summary

### NEWARK PROCESSING

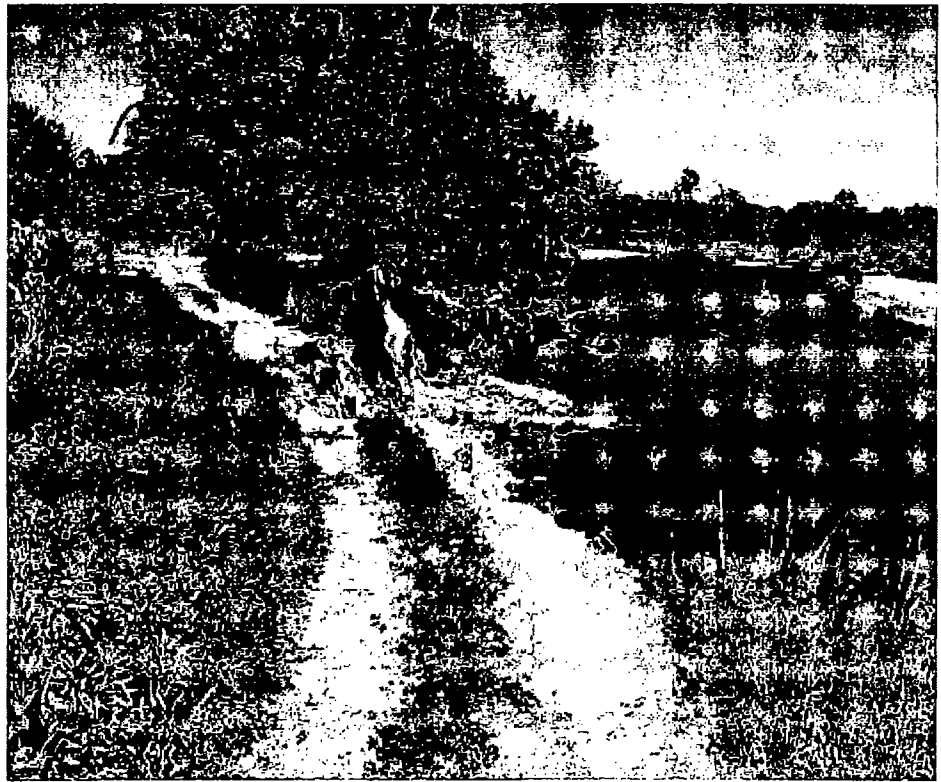
Photograph 1: Erosion of the site by the Licking River in 2004.

In 2004, Ohio EPA noted that the Licking River was beginning to erode into the stockpiled material. The material is not as resistant to erosion as native soil and prior attempts by Newark Processing to stabilize the bank had been breached. In 2005, the Ohio EPA decided to contract with the United States Army Corp of Engineers (USACE) for assistance due to their expertise and constructing stream bank stabilization projects.

Ohio EPA is currently working with USACE concerning the erosion of the dross. A memorandum of understanding was signed between Ohio EPA and USACE on December 14, 2006 and a contract was awarded on March 14, 2007. On April 16, 2007, Ohio EPA provided USACE \$2.8 million for the stabilization project. The project will stabilize about 1,600 feet of river bank. The work will include 1) removal of vegetation, rubble, drift and other debris; 2) placement of approximately 17,000 tons of stone; 3) placement of about 21,000 cubic yards of fill material; and 4) placement of about 6,550 square yards of geotextile fabric in the embankment area.

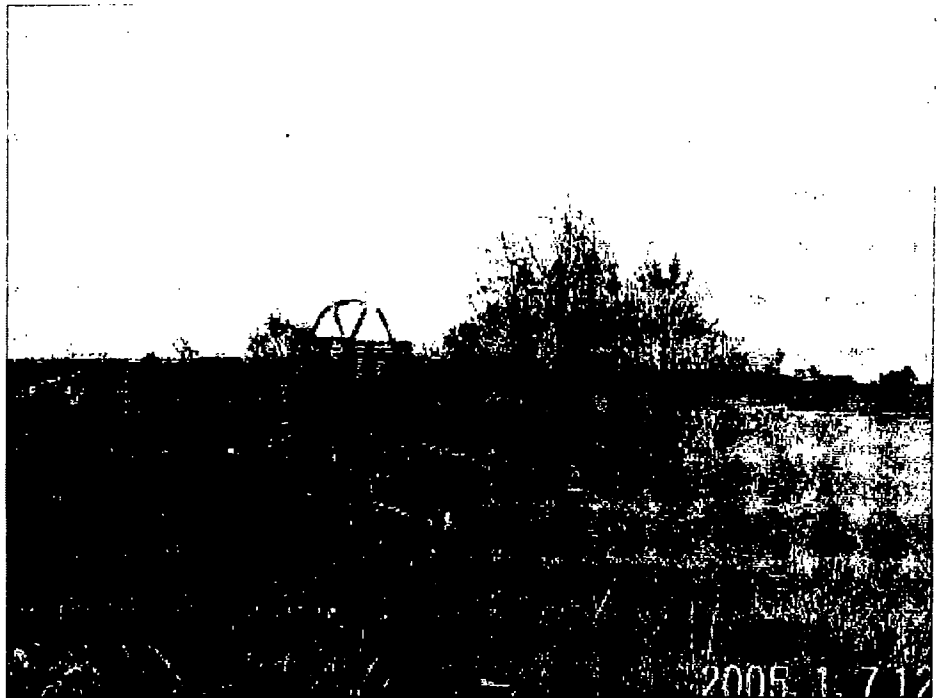
Photograph 2: Erosion of the site by the Licking River in 2005. Note the partial disappearance of the road as seen in the 2004 photograph.

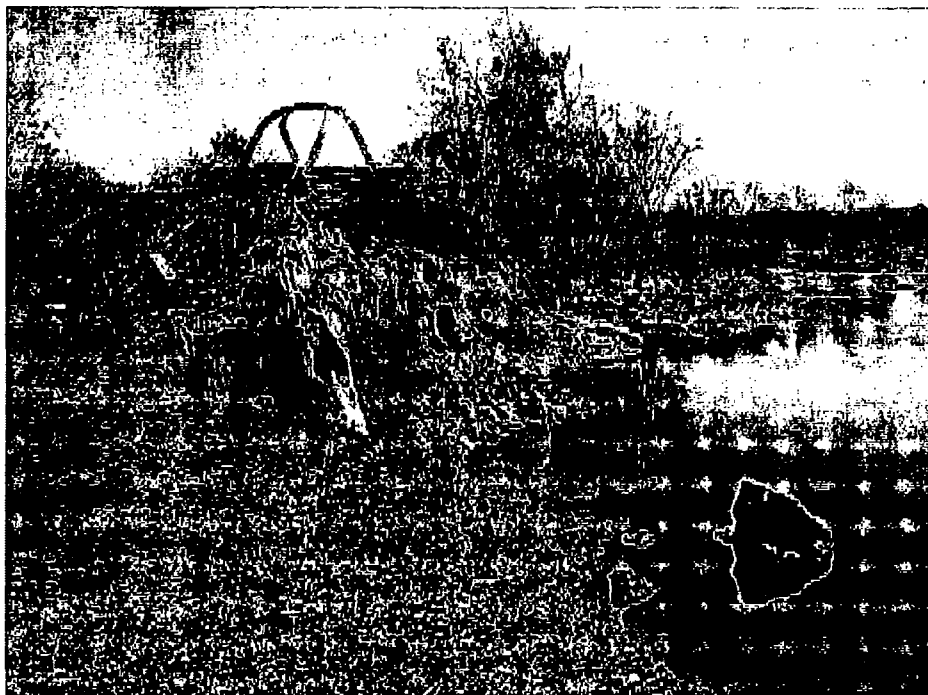
Photograph 3: Erosion of the site by the Licking River in 2007. Note the disappearance of the monitoring well as seen in the 2005 photograph.
